Location:
Northern Massachusetts

Building Type:
New Residential
Construction

A Big Splash

Closed Cell Spray Polyurethane Foam (SPF) Meets the Challenge of an Indoor Pool in a Cold Climate

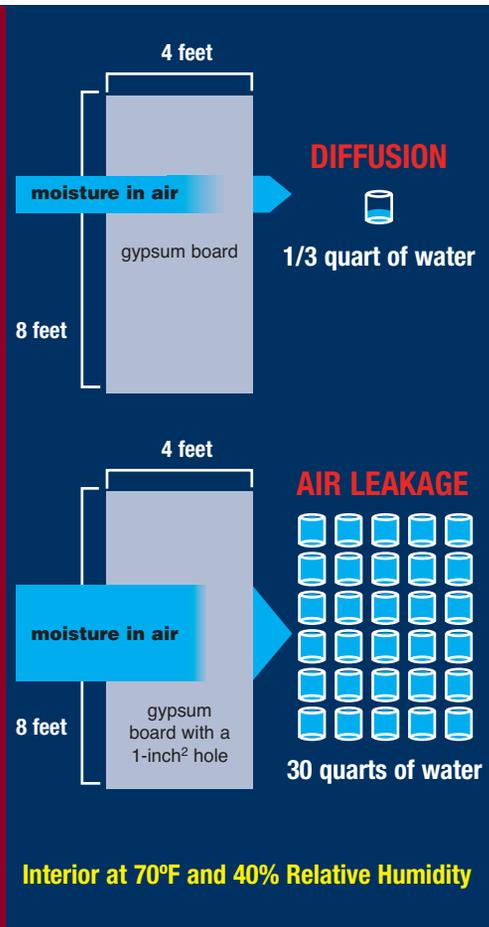
The above diagram highlights water transport via diffusion and air leakage. Source: Energy & Environmental Building Alliance (EEBA)

different mechanisms into wall assemblies: **air movement** and **diffusion**. Air movement is typically the larger source of moisture problems, as a 1-inch hole @ 70°F and 40% relative humidity will allow 90 times more water into a wall via **air leakage** than a 4 foot x 8 foot gypsum board will via **diffusion**. Thus, an air barrier not only improves energy efficiency, it also serves as the first defense against moisture problems.

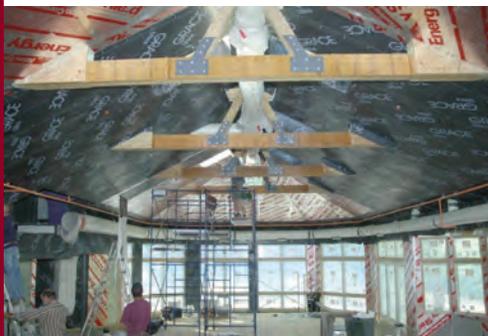
Vaulted ceiling assembly being installed
